Manhole Inspection Summary

Manhole # S55I__036MH

Location Address: **511 s highland ave**

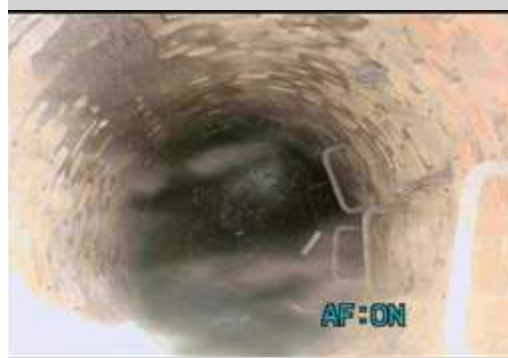
Top View

top view & steps

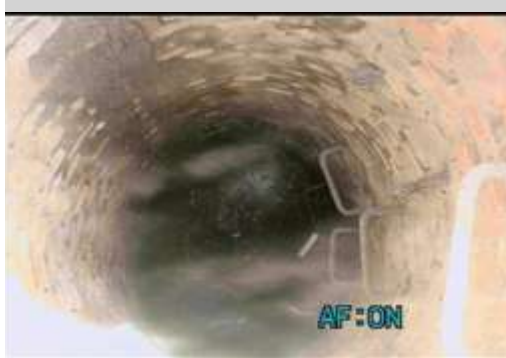
Defect 2

Count: **6** Missing: **1** ☒ **Corroded**

steps

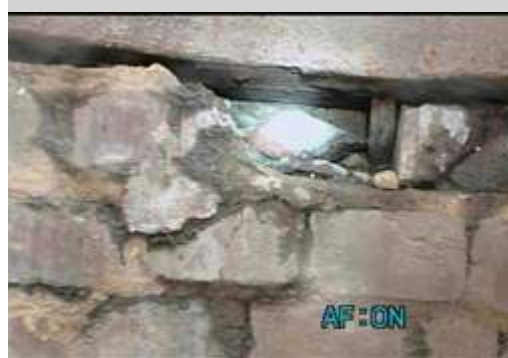
Defect 1

Condition: ☐ Sound ☒ **Cracked** ☐ Root Intrusion ☒ **Loose Brick** ☐ Deteriorated

corbel cond cracked, corbel cond loose bricks

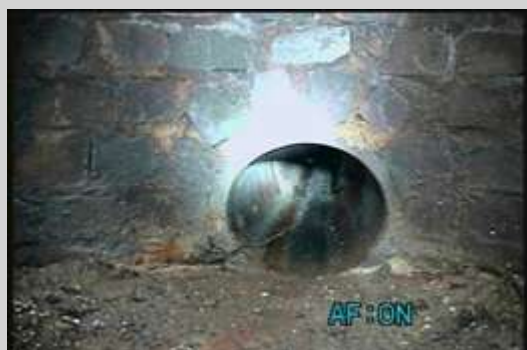
12 O'Clock Outflow

8 in. Circular Gravity Sewer
Pipe Out @ 12 O'Clock
